Reparability of Reinforced Concrete Special Moment Resisting Beams

MUHAMMAD RASHID^{1*}, NAVEED AHMAD²,

¹Department of Civil Engineering, University of Engineering and Technology Peshawar, KP Pakistan

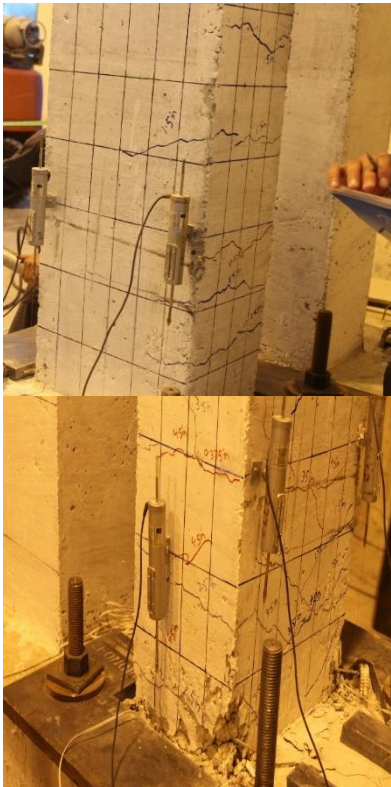
Figure 4: Specimen Damage Patterns

The specimen was loaded with an initial displacement of 0.375 in. Full depth flexural crack formed at the northern face of the beam at a distance of 18 in. from the face of the block, whereas a flexural crack at a distance of about 16 in. formed on the southern face. Cracking was not observed on the eastern and western faces at this displacement demand. At a displacement amplitude of 0.75 in., no new cracks formed on any face of the beam. With further increase in displacement demand to 1.5 in., new flexural cracks formed at 8 in., 13 in. 26 in. and 34 in. from the support on the southern face. A flexure crack formed at northern face at a distance of 27 in., whereas slight diagonal cracking occurred on the western face. A wide distribution of cracks took place during the displacement cycles of 2.5 in., with cracks on the northern and southern faces as high as 54 in. Full depth inclined cracks were observed on the eastern and western faces of the beam which increased in number at displacement demand of

3.5in. Minimal new cracks were observed further till the conclusion of test at 5.5 in.

Spalling of the concrete cover started on the northern and southern faces at a displacement of 4.5 in., which escalated at final the displacement cycles of 5.5 in exposing the reinforcing bars on the southern face. The specimen could not be displaced further because the maximum stroke of the hydraulic jack was 6 in. The hysteretic response was marked by a strong pinching due to the slip of longitudinal bars. No strength drop was observed in the hysteretic response due to the fact that the specimen was not tested till failure as shown in Figure 5.

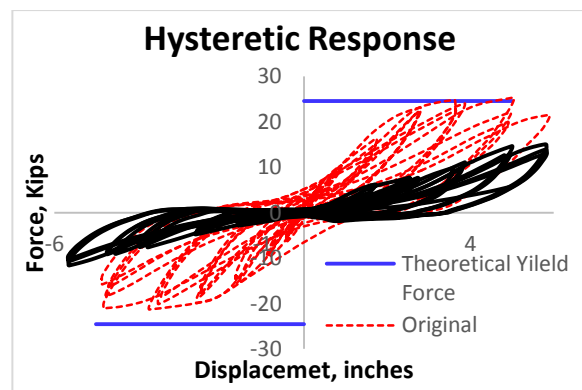
Figure 7: Comparison of Original & Repaired Response of Spectrum

The response of the repaired specimen was unsatisfactory. The beam showed a considerable drop in the strength and a severe pinched hysteretic response due to loss of stiffness Figure 7.

The reason behind this performance is the fixed end rotation at the interface between the beam and the anchorage block. The interface opening was injected with epoxy but based on the results it can be said that the merely filling the interface opening with epoxy will not restore the original stiffness of the beams which will render the beam unable to achieve its original strength. The efficiency of the epoxy injection in treating the cracks could not be studied due to the fact that the beams did not sustain the original loads which caused those cracks.
