## Analysis of Damage of Degraded Slitting Knife

**Abstract:** This study analyzed the damage to a slitting knife after cutting steel sheets. Damages to the structure were observed and wear tests were conducted. In addition, the degradation on the damaged and undamaged parts was compared with a Vickers hardness test. Weibull statistical analysis was carried out in order to evaluate the reliability of the Vickers hardness measured data. Spalling of the edge portion occurred by degradation during use over a long period. Rough parts in the specimens were caused by damage because the slitting knife was used for 1 year. The friction coefficient and wear loss at the damaged parts of the knife edge were slightly larger from shock due to repetitive cutting operation. The Vickers hardness followed a two-parameter Weibull probability distribution.

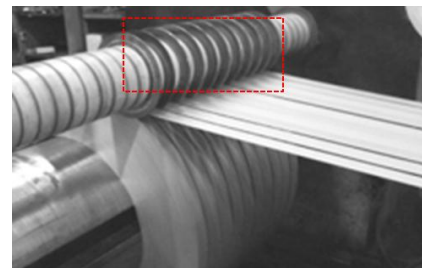
Fig. 1 Appearance of slitting knife

Fig. 1 shows the appearance of the slitting knife. This was used during one year on site of automobile parts manufacture. This has peeling the surface by the degradation.

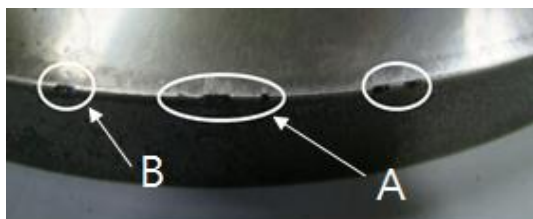
Fig. 4 Spalling failures at the slitting knife edge

Fig. 4 shows a damaged part of the slitting knife. The circle shows the edge of the slitting knife and outlines the damage to the material in contact with the steel sheet. The damaged area exhibits a spalling pattern from the vibration caused by contact with the upper and lower molds. This degraded the hardened layer of the surface with repetitive cutting action, and was peeled off by an external shock.

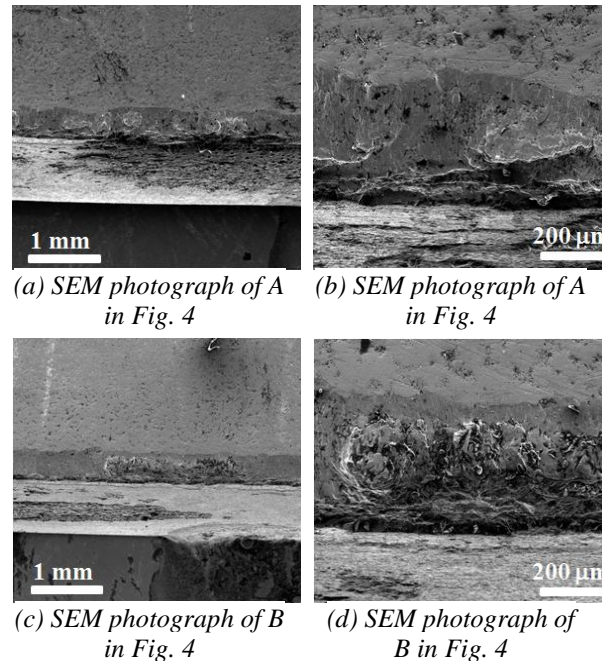
Fig. 5 SEM photograph of spalling failure parts

Fig. 5 is the SEM observation result for Fig. 4 and illustrates the damage from the impact caused by rotation. Peeled parts containing a lot of defects and impurities were observed, confirming deep flaws in the longitudinal direction, which is typical in spalling damage.

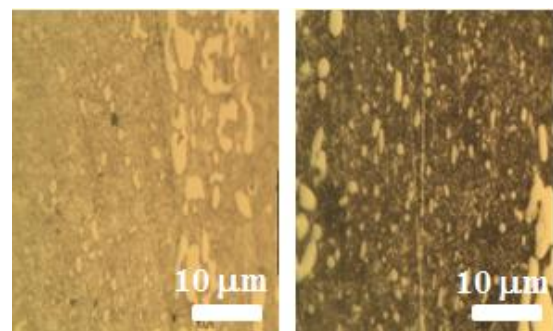
Fig. 6 Microstructure observation of spalling failure part and base metal

Fig. 6 shows the structure in the base material with and without damage. Generally, toughness is lost by quenching and regained by tempering. The base material formed a tempered-martensite structure with high strength and toughness, but the the damaged part shows a somewhat coarser spheroidizing structure. Therefore, the material was changed from a martensite structure to a spheroidizing structure with degradation. Due to the spheroidizing structure, peeling occurs easily with an external impact.

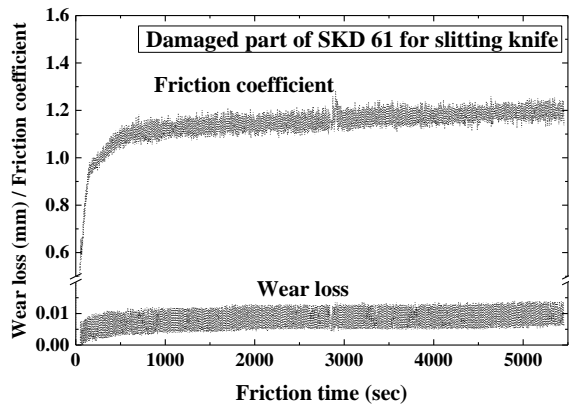
Fig. 7 Wear loss and friction coefficient according to friction time

A wear test was conducted on the inside (a portion close to the radius of the slitting knife), surface and damaged parts (knife edge) of the slitting knife. Fig. 7 shows the wear loss and the friction coefficient of the damaged part.

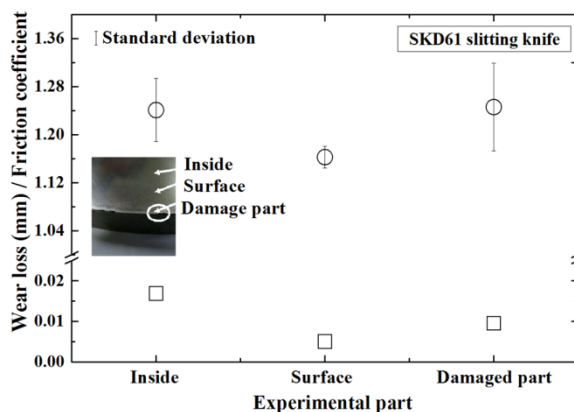
Fig. 8 Wear loss and friction coefficient according to experimental part

Fig. 8 shows the average wear loss and the average friction coefficient obtained from the three areas subjected to wear tests. Specimens became damaged as the slitting knife was used over a period of 1 year. Therefore, the friction coefficient and wear loss at the knife edge was slightly larger. The friction coefficient and wear loss of the heat-treated surface was small while the inside showed larger damage than the polished edge because of cutting. Tables 1 and 2 show the mean, standard deviation (STD), and coefficient of variation (COV) according to mathematical statistics

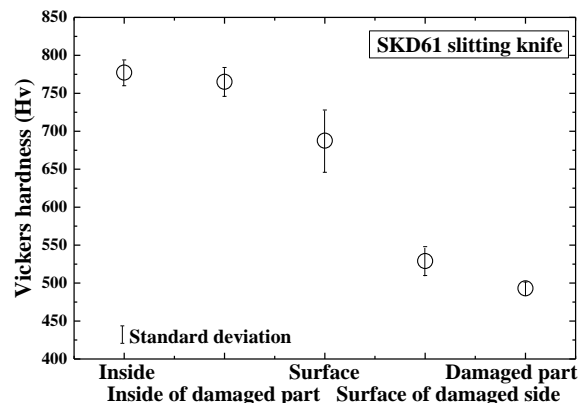
Fig. 9 Vickers hardness according to specimen conditions

Fig. 9 shows the mean Vickers hardness measured at each location. The mean value of the Vickers hardness was approximately 760 and 687 Hv on the inside and the heat treated surface, respectively. On the other hand, the corresponding values on the surface of the damaged side and the damaged part were 530Hv and 493 Hv, respectively. The damaged part showed the smallest value. This is because the peeling occurred from shock due to repetitive cutting operation.

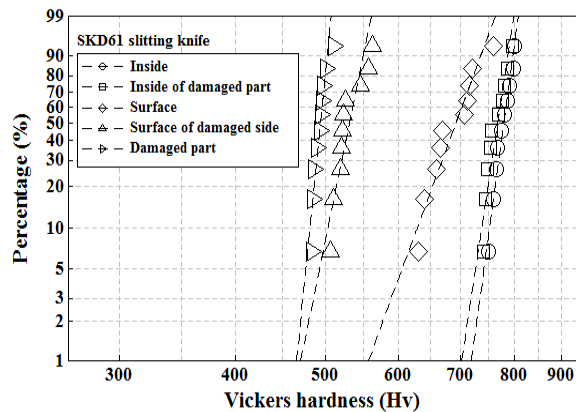
Fig. 10 Weibull plot of Vickers hardness values

Fig. 10 shows the Vickers hardness according to the Weibull probability. Since hardness is expressed as a straight line, it can be seen as applicable to the Weibull probability distribution. The Vickers hardness of the damaged specimens ( $\triangle$ ,  $\triangleright$ ) was significantly lower than that of the inside specimens ( $\circ$ ,  $\square$ ). The value for the surface specimen ( $\diamond$ ) was higher than for the damaged specimen ( $\triangle$ ,  $\triangleright$ ), but was lower than for the inside specimen ( $\circ$ ,  $\square$ ). This is caused by degradation due to use.
