## **Investigation of highway geometric problems and remedial measures in Rajshahi City corporation area, Bangladesh**

**MD. ABDULLAH AL IMRAN, BULBUL AHMED and MD. KHAIRUZZAMAN BHUIYAN**

*Department of Civil Engineering, Rajshahi University of Engineering and Technology, Rajshahi, Bangladesh*

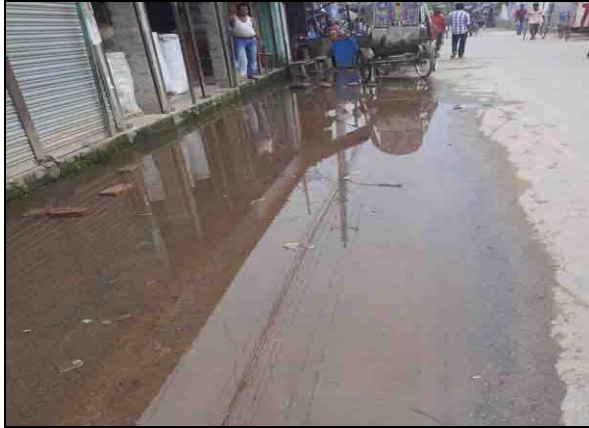
When water from any source find no path to escape or drain out and create a hazardous situation is known as water logging. Excessive rainfall, inadequate drainage sections, conventional drainage system with low capacity and gravity, natural siltation, absence of inlets and outlets, indefinite drainage outlets, lack of proper maintenance of existing drainage system, and over and above disposal of solid waste into the drains and drainage paths are accounted for the prime causes of water logging. From the observation of road network in RCC it has been found that during rainy season many roads are affected by water logging. This is cause due to absence of any drainage system, improper maintenance of drainage facilities etc. A road with serious water logging problem was found beside the New Market which is shown in figure 2.

Figure 2: Water logging situation on New Market to Nagar Bhaban road due to absence of drainage system

In order to remove surface water, longitudinal RCC drains should be provided maintaining proper shoulder at important bazaar places, which is shown in figure 15.

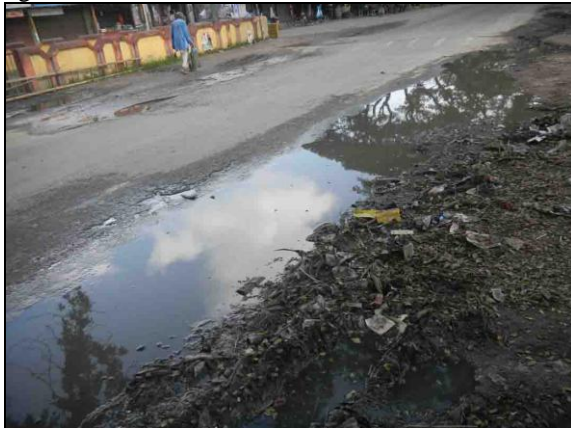
Soil stability refers to the engineering properties of a soil specifically its resistance to failing when disturbed. Soil stability depends on its shear strength, its compressibility and its tendency to absorb water. The stability of a soil gradually decreases due to long term water logging situation. As soil stability decreases, the bearing capacity of soil also decreases and the soil is failed at slope. This type of situation was found at Naudapara Bazar which is shown in figure 3.

Figure 3: Soil stabilities gradually decrease due to long term water logging situation at Naudapara Bazar

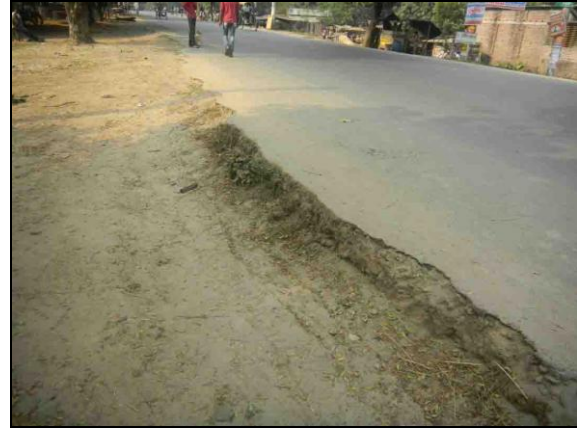
Water allowed to remain on top of a gravel or paved road weakens the surface and combined with traffic, causes potholes and cracking. If there is absence of drainage system, water wash out the particles and causes soil erosion and a breakdown of pavement edges. Due to continuous erosion of pavement, lessen the width of road and creates danger zone which is responsible for serious accident. So inadequate drainage facilities is the crucial reason for erosion of pavement. The serious erosion occurred at a point of Rajshahi to Natore road as shown in figure 4.

Figure 4: Inadequate drainage facilities cause serious deterioration of the pavement by continuous soil erosion at Katakhal

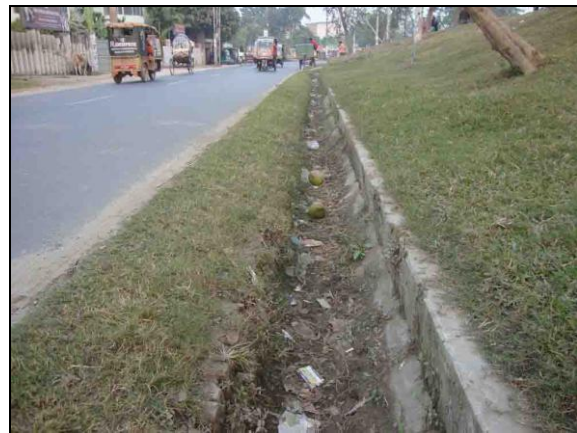
Grass, weeds, brush etc. are responsible for blockage of drain. If they are not control regularly may block the road side drain and creates serious condition such as water logging on road surface, environment pollution etc. The drainage system in many places of Rajshahi city is suffered with this problem. Which is due to insufficient maintenance work. A drainage system running parallel with Talaimari to Saheb Bazar road is blocked by bushes and sharbs is shown in figure 5.

Figure 5: Road side drain blocked by bushes & sharbs near Hadir Mor

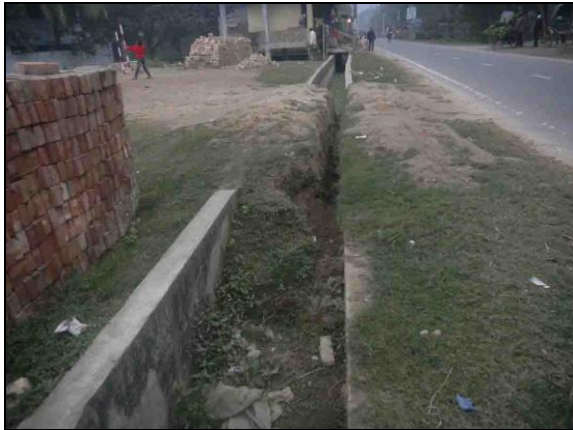
Sometimes the drainage may be block by dumping of soil into it. It is done by local people for walking purpose and for crossing goods from one side to other side of the drain. This problem hampers the drainage facilities and creates water logging situation. In Rajshahi city this problem was seen beside the Vodra to Meherchondi road which is shown in figure 6.

Figure 6: Drainage is blocked by dumping of soil beside Vodra to Meher Chandi road

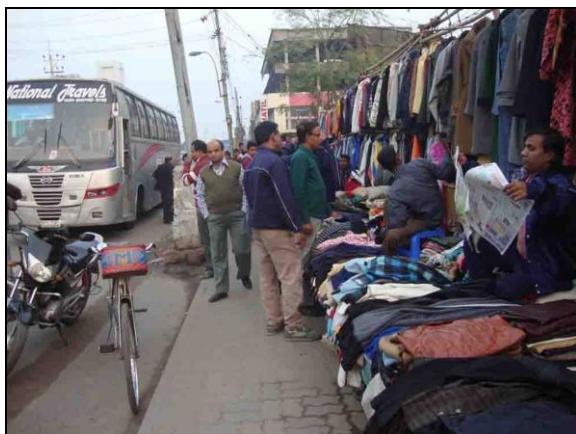
It has seen that the shoulder of the road at Rajshahi railway station is occupied by hawkers which creates so many problem and shows in figure 7.

Figure 7: Shoulder on both side of the road is occupied by hawker at Rajshahi railway Station area

- Illegal establishment should be removed from the pavement shoulders.
- Specific road side parking place should be provided to park the vehicles.
- Hawkers from shoulders should be removed.
- Overall law and order situation should be sound enough to take proper steps against the powerful local influential.
- Bushes should remove from shoulder.
- Sign-post and rules can apply.
- Traffic law enforcement is meant to achieve the safe and efficient movement of all road users.

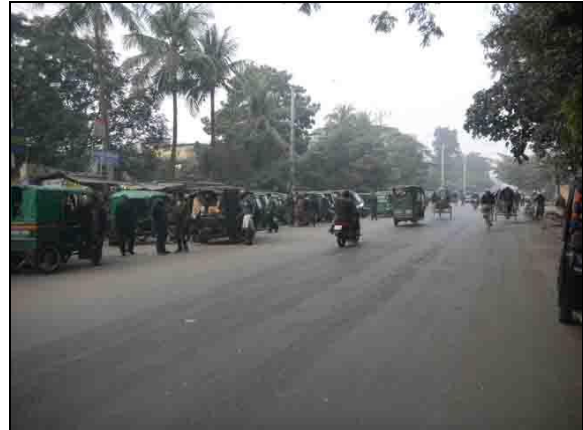
Rail station, Saheb Bazar, Rail gate etc. These public transports as a result use carriageway for stopping, parking, dropping, picking and waiting for passengers and goods. And the local drivers drive vehicles without any training. Most of the driver has no any idea about the traffic rules. So they parked their vehicles on shoulder, and creates traffic jam. It is often seen at the rail gate area, the easy bikes, CNGs etc. are parked on shoulder as shown in figure 8.

Figure 8: Illegal parked vehicles on shoulder at Rail gate area

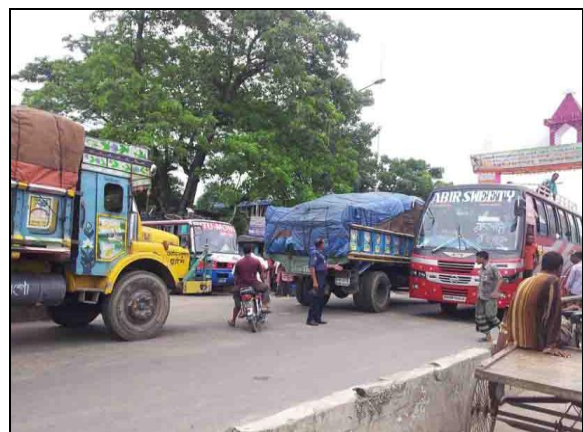
Due to this illegal parked vehicle sometimes serious traffic jam creates, which is responsible for the inconvenience to the passengers. A traffic jam was found at Binodpur area which is shown in figure 9.

Figure 9: Serious traffic jam creates due to illegally parked vehicle on shoulder at Binodpur area

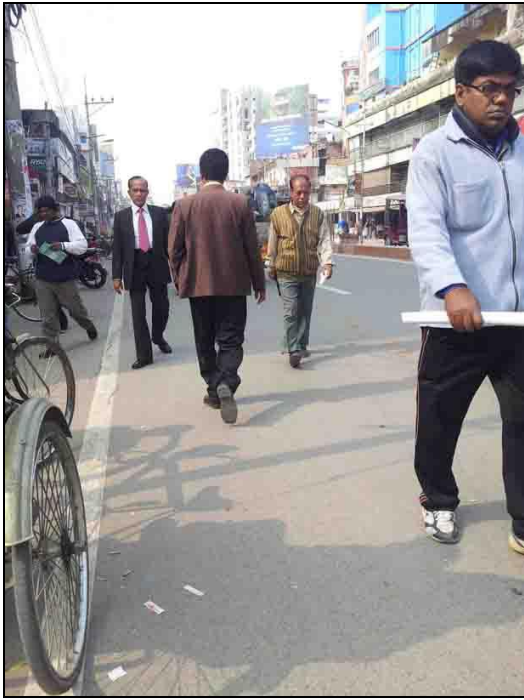
Most of the hat-bazars, markets, shopping malls, schools, colleges and universities are situated beside the roads. For this reason the road pavement is used by local people for walking purpose. Thus the road width is reduced and accident occurs. People likes to use pavement surface for walking than unpaved surface. They do not care about the traffic rules or even don't know the rules. Similar type of feature was seen at Shaheb Bazar area which is shown in figure 10.

Figure 10: Local people use pavement for walking at Shaheb Bazar

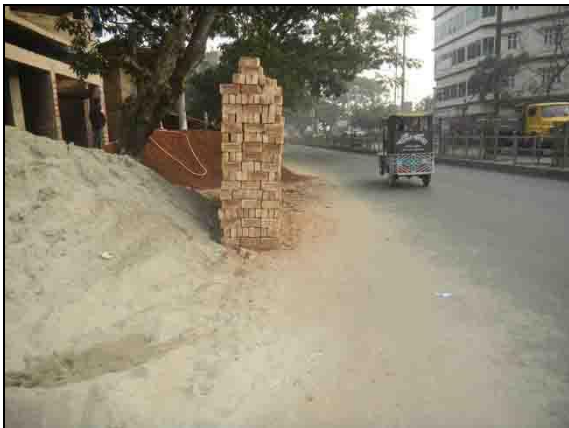
The shoulder is blocked by bricks, sand etc. which was found at Vodra area is shown in figure 11.

Figure 11: Shoulder is blocked by construction material both side of the road at Vodra

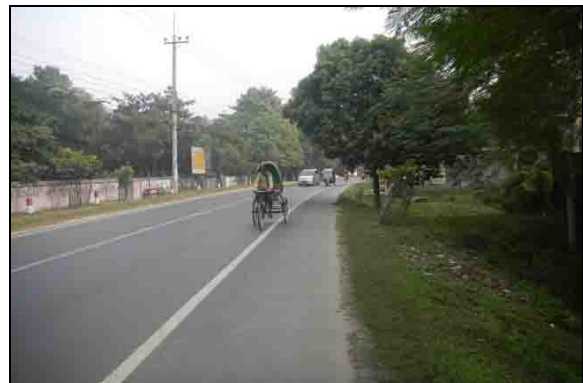
Collusion between vehicles have been occurred due to inadequate lateral space of emergency overtaking and the vehicle may run off the pavement. The road section passes beside the main gate of Rajshahi University are affected by this problem, which is shown in figure 12 and 13.

Figure 12: Inadequate horizontal clearance at the place of curve in front of Rajshahi University

- a) RHD’s operational division should take proper steps to maintaining sufficient horizontal clearance.
- b) Plantation of trees on the road side is the job of local administration, they should aware about that.
- c) The drivers should move slowly at the place of curve.
- d) Adequate signs should be provided at the place of curve.
- e) Proper super elevation should be provide at curve.
- i. Adequate horizontal clearance at the place of curve:

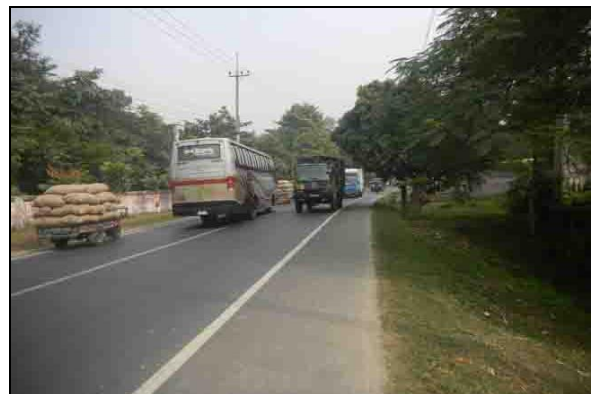
Figure 13: Serious conflict may occur due to inadequate horizontal clearance at the place of curve

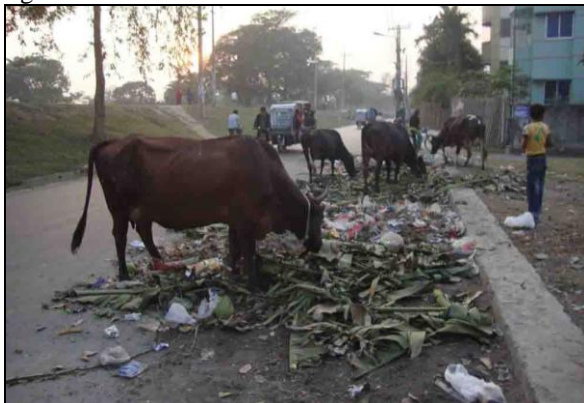
The deposition of waste on the edge of the pavement may pollute the water source, particularly wells, tube wells, ponds etc. odor nuisance may also pollute air. This may create various problem. While planning development of roads and transportation facilities, apart from aiming at operational efficiency, it is also necessary to consider the quality of the environment due to the development. It is important to prepare the environmental impact statement at the planning stage itself. But in the case study of the Rajshahi city corporation road, it has been found that illegal dumping of solid and hazardous waste at Hadir Mor causing serious air and water pollution is shown in figure 14.

Figure 14: Illegal dumping of solid waste all most on the pavement causing environmental pollution at Hadir Mor.

- a) RCC should take proper steps to keep clean the hat-bazar and both side of the pavement.
- b) Local administration should use the law to keep the pavement clean.
- c) Roadside dustbin should be provided by the authority.
- d) People should be aware about the environment pollution and not to through the dust on the pavement.

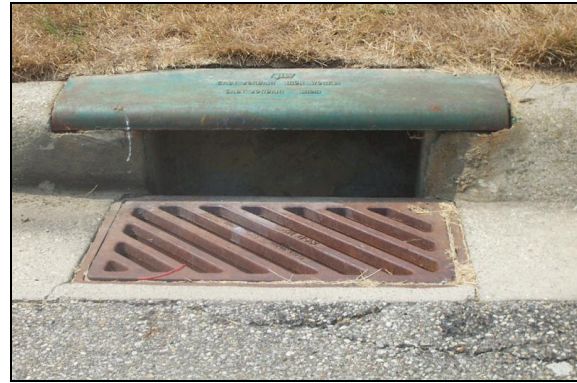
Figure 15: Road with surface drainage

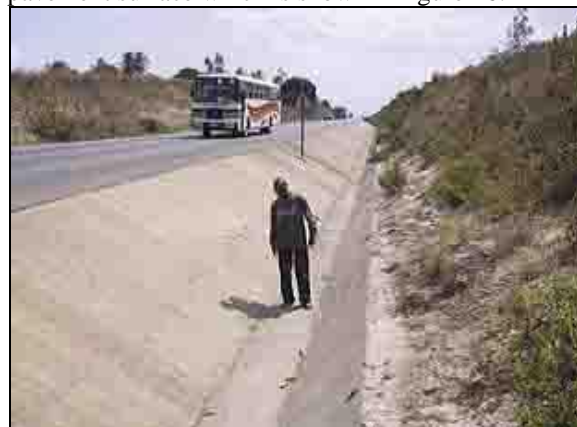
Trapezoidal drainage should be provided beside the road to remove rain water immediately from the pavement surface which is shown in figure 16.

Figure 16: Trapezoidal drainage system

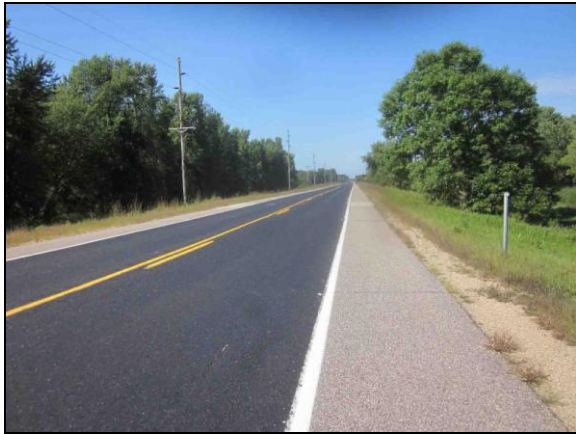
An example feature that could be applied to avoid the shoulder problem is shown in figure 17.

Figure 17: A road with proper shoulder

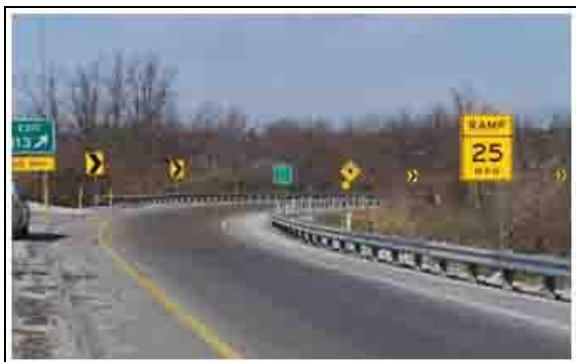
An example of standard horizontal clearance that could be applied at place of curve is shown in figure 18.

Figure 18: Adequate horizontal clearance at the place of curve

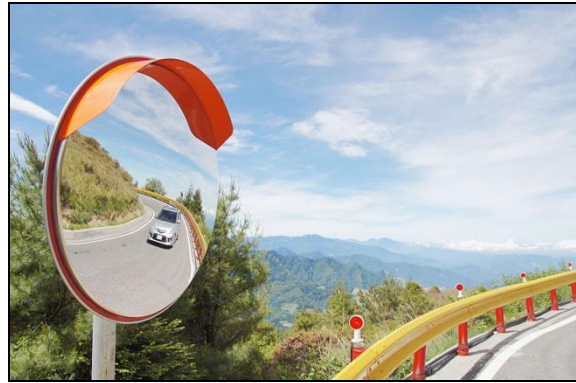
- ii. Use of road safety mirror:
- The road safety mirror can be used at the place of curve which helps the drivers to see the vehicle come from the opposite direction and move their vehicle safely. An example is shown in figure 19.

Figure 19: Safety mirror can be used at the place of curve

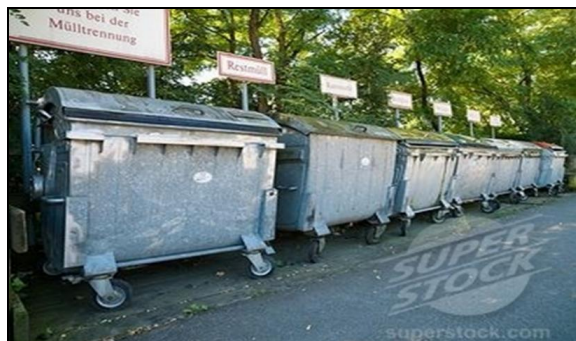
An example of roadside dustbin that should be suggested is shown in the figure 20.

Figure 20: Road side dustbin should be suggested
