Reparability of Reinforced Concrete Special Moment Resisting Beams

MUHAMMAD RASHID^{1*}, NAVEED AHMAD²,

¹Department of Civil Engineering, University of Engineering and Technology Peshawar, KP Pakistan

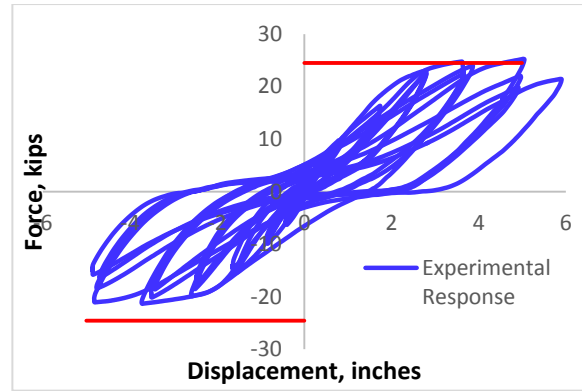
Figure 5: Hysteretic Response

Spalling of the concrete cover started on the northern and southern faces at a displacement of 4.5 in., which escalated at final the displacement cycles of 5.5 in exposing the reinforcing bars on the southern face. The specimen could not be displaced further because the maximum stroke of the hydraulic jack was 6 in. The hysteretic response was marked by a strong pinching due to the slip of longitudinal bars. No strength drop was observed in the hysteretic response due to the fact that the specimen was not tested till failure as shown in Figure 5.
