## Analysis of Damage of Degraded Slitting Knife

**Abstract:** This study analyzed the damage to a slitting knife after cutting steel sheets. Damages to the structure were observed and wear tests were conducted. In addition, the degradation on the damaged and undamaged parts was compared with a Vickers hardness test. Weibull statistical analysis was carried out in order to evaluate the reliability of the Vickers hardness measured data. Spalling of the edge portion occurred by degradation during use over a long period. Rough parts in the specimens were caused by damage because the slitting knife was used for 1 year. The friction coefficient and wear loss at the damaged parts of the knife edge were slightly larger from shock due to repetitive cutting operation. The Vickers hardness followed a two-parameter Weibull probability distribution.

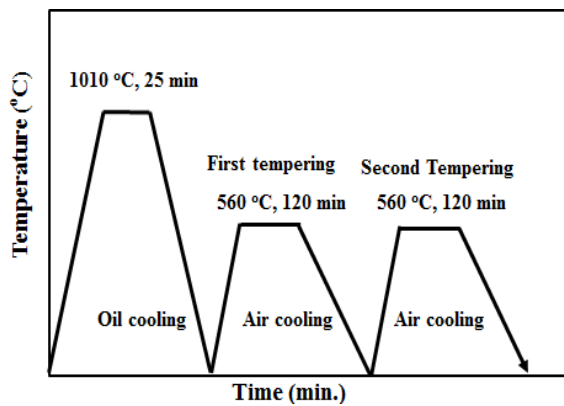
Fig. 3 Heat treatment conditions

Fig. 3 shows the heat treatment conditions for SKD61 steel. Heat treatment was performed with oil-cooling after quenching for 25 minutes at 1010°C. Tempering was carried out twice with air-cooling over 120 minutes at 560 °C. Damaged parts were examined with SEM at 300x and 70x magnification. In addition, mirror-polished specimens were etched with a solution of 95% FeCl<sub>2</sub> + 5% distilled water, and structures were observed with a metallurgical microscope.
